# LEICA 1000 Power Optical Microscope

for Electrical Failure Analysis Laboratory in ONPY

Introduction on Refurbished Leica microscope for analytical purposes

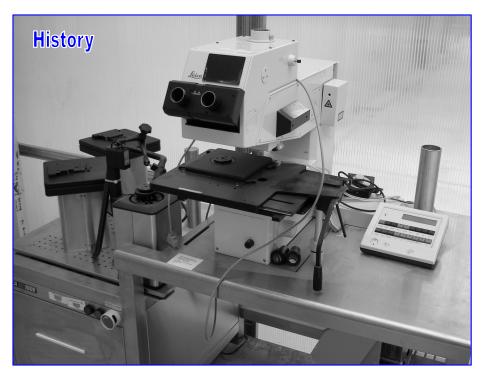
- Burned controller Board (Basic module)
- Missing Robot (not required for analytical purposes)
- Missing 50x, 100x objectives and oculars
- Broken image mirror selector
- Broken Aperture selector
- Broken halogen lamp power source,
- missing UV source, broken UV housing
